CleanAtlantic

DELIVERABLE 7.2

Applicability of a modular basic ROV to detect marine litter
in Galician shores: constraints and improvements

WP 7: Tackling Marine Litter

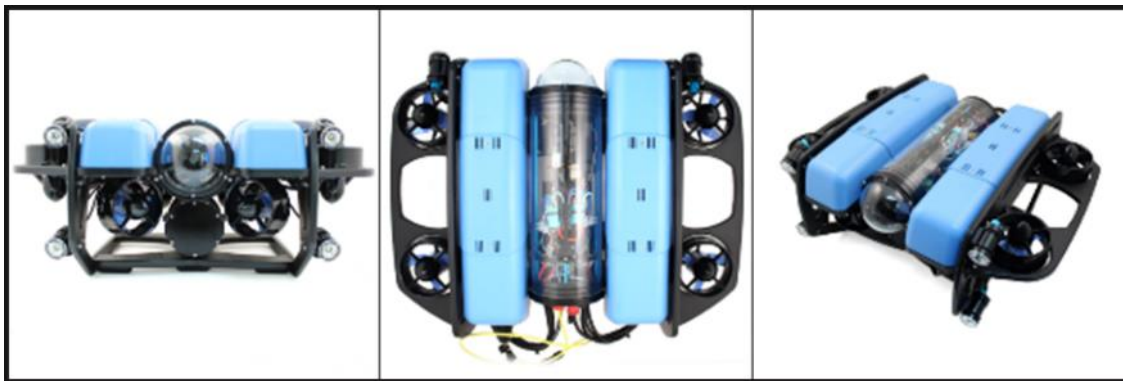
After considering technical and budgetary aspects, it was decided to acquire the BlueROV2 Heavy Configuration Retrofit Kit³ (Figure 2). This is a low cost model when compared with more advanced ones. Another key asset of the BlueROV2 is the open-source electronics and software which allows expanding and upgrading their components, configuration and performance (<https://bluerobotics.com/>).

Figure 2. Images of BlueROV2 taken from different angles.

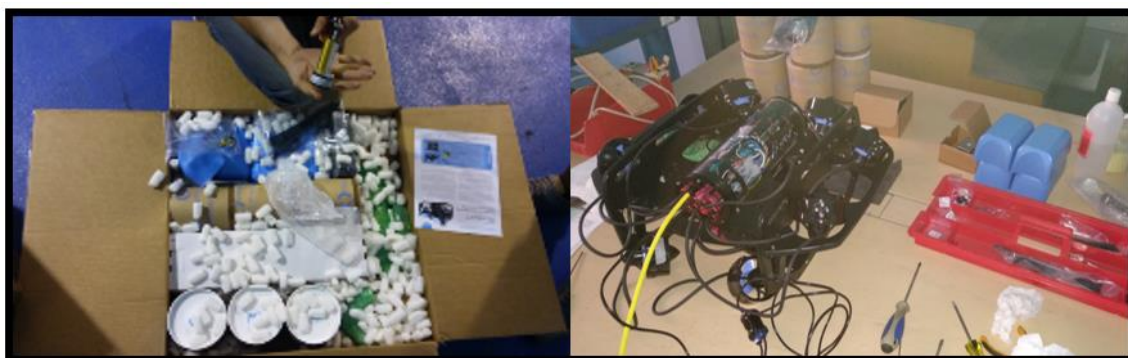
All the ROV components were received in August 2019 and assembled in the Unit of Marine Technologies of CETMAR (Figure 3). During the project life time, and based on the outcomes of the field tests, different improvements were implemented in order to get a better performance and operational capacity and to reinforce communication systems. The main upgrades carried out are listed below:

Figure 3. ROV components and assemblage in CETMAR facilities.

- Change of the wiring systems, to make it removable and add new communication and power lines for the sensor module. Revision and adjustment of the wiring systems to ensure tightness.
- Wi-Fi communications installation, allowing the use of a GPS positioning buoy.
- Creation of a visual device to view underwater images without using a PC.
- Integration of two compartments for extra batteries.
- Installation of a gripper clamp.
- Installation of an extra camera.

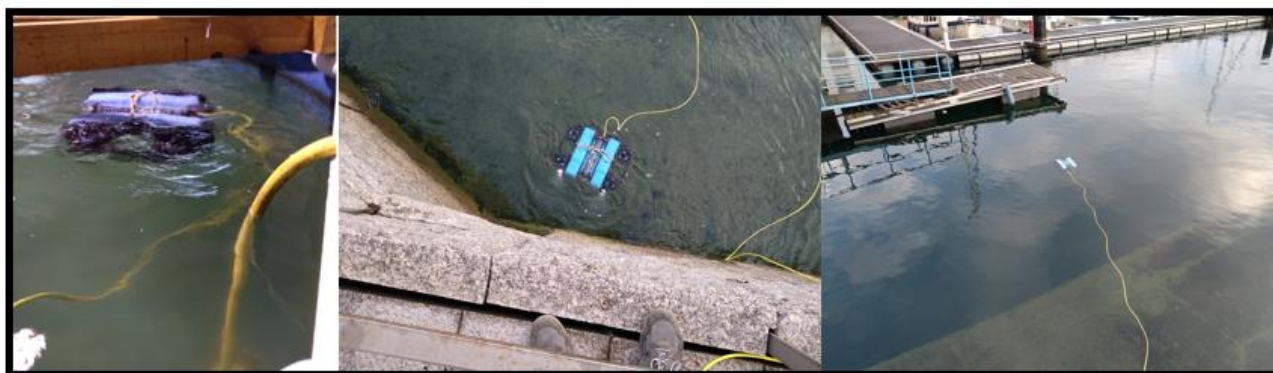
Initial tests were carried out in a pool located at the Unit of Marine Technologies premises in CETMAR to check its buoyancy and basic performance (Figure 4).

Figure 4. Indoor and from land test carried out in CETMAR facilities.

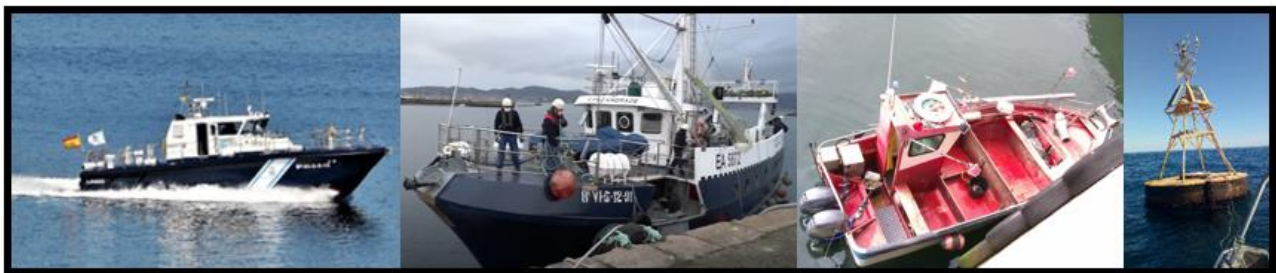
Figure 7. Galician Coast Guard vessels, small scale fishing vessel and oceanographic buoy used as platforms to operate the ROV.

The fact that both of the Galician Coast Guard boats had a cabin equipped with additional technology was considered a positive factor, since it provides useful and accurate information (positioning, depth, etc.) and allows working under bad weather conditions, like rain, that could negatively affect electronic devices

(computers, monitors, etc.). On the contrary, the boat size difficult the ROV operation when its location has to be corrected regarding the position of the vessel at rest, being more operational and faster in these cases to use smaller vessels.

Although these tests confirmed that small boats enable much easier vehicle handling, the functioning can be more affected by meteorological conditions, like rain or glare caused by sunlight on the computer monitor. A constraint noticed during this first field test series was the low autonomy of the batteries, which reduced the immersion time to periods of less than 30 minutes. This limitation was fixed by the inclusion of extra compartments in the ROV to install two additional batteries, which were connected between them, thus considerably extending the dive duration.

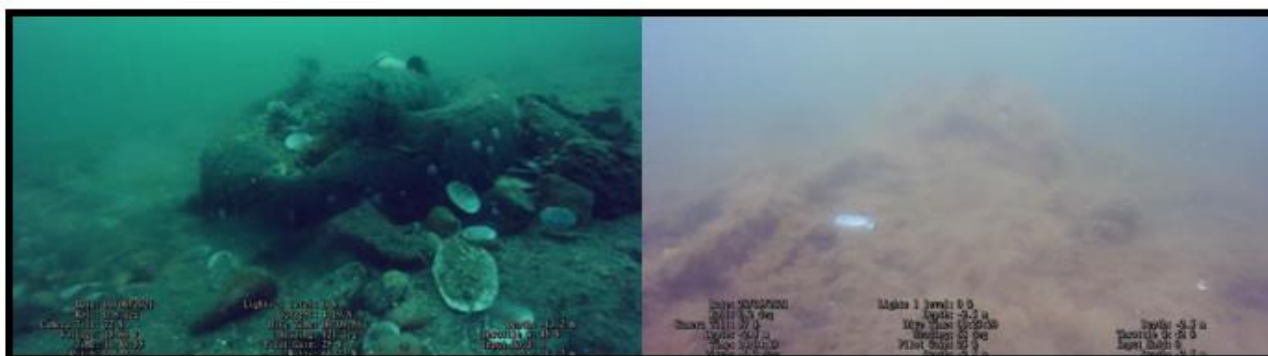
In the last months of 2020 and early 2021, as already detailed in the equipment section, different improvements were implemented in the ROV in order to sort out some of the issues identified, getting a better ROV performance and handling. Due the predominant bad weather, new tests were postponed until February 2021, when a first immersion was carried out in the Port of Vigo from a small vessel without cabin, which allowed us to survey different locations of the docks at a depth that ranged from 3 to 16 meters. The low visibility, around 0.5 m ahead, did not allow us to obtain a high-quality filming, although items like tyres that are normally used like boat fenders were detected (Figure 8).

Figure 8. Images recorded in the first test carried out inside the Ria de Vigo and Port of Vigo harbour.

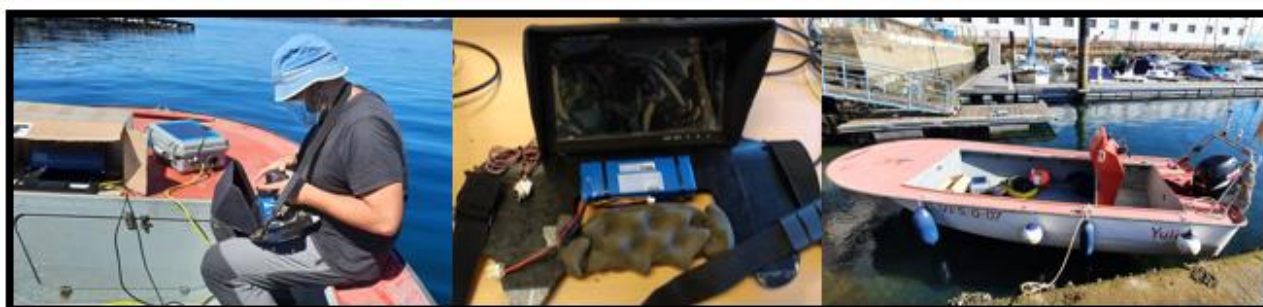
Taking into account the previous trials, it was decided to use a small-scale boat (approximately 6 m long), allowing us to minimize some of the handling issues identified during the first immersions and easily correct drifts in the position. In addition, a visual device, connected by a HDMI cable to a computer, was implemented, allowing the view of images without using a PC and reducing the screen glare caused by the sunlight (Figure 9). Moreover, a Go-Pro® camera was also installed in the ROV structure, enabling to obtain videos from different angles, thus providing additional information.

Figure 9. ROV operator using the visual device and the boat employed during this second round of dives.

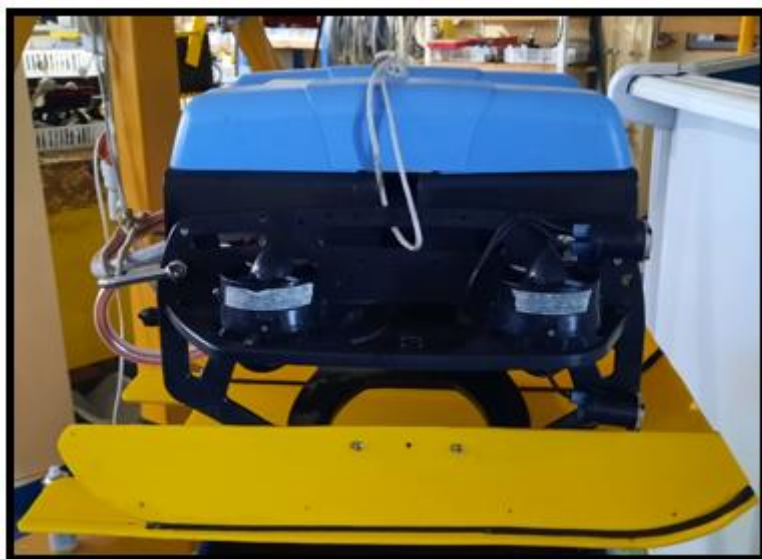
- A waterproof high brightness (1000 nits) monitor should be included to avoid rain or glare effects.
- A crucial issue is to avoid potential entanglements in seafloor colonized by some species like sea pens or high algal coverage. Navigation in these conditions, very common inside the rias, needs to be done far from the bottom, a position that could affect the location and identification of marine debris. In soft substrates a potential solution to be implemented is the use of a drag sled under the ROV. Such sled is already available in CETMAR's headquarter and it will be tested in future field tests (Figure 11).

Figure 11. ROV drag sled prototype.
